## Plot of Stability of Decay Solenoid

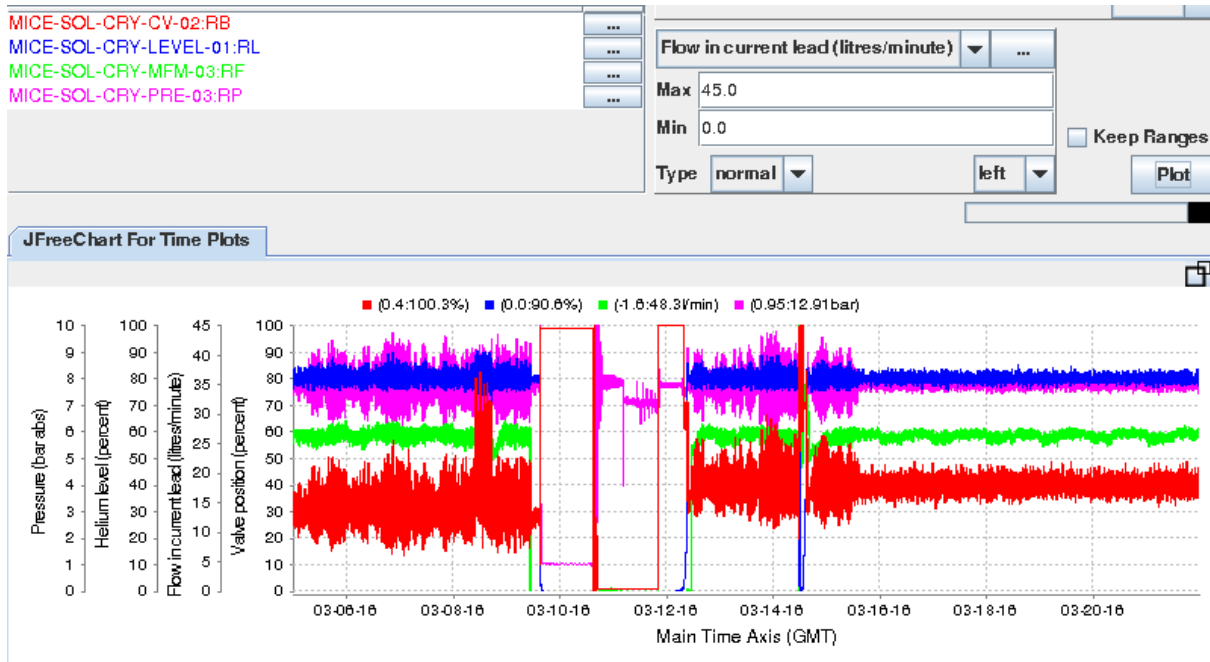
Pre March 10<sup>th</sup>: instability of compressor/Linde/DS cryostat – large oscillations in pressure, valve positions, and helium level resulting in frequent alarms causing consternation in the MLCR

March 10<sup>th</sup> to 12<sup>th</sup>: Cleaning of gas in Linde circuit

March 12<sup>th</sup> to 15<sup>th</sup>: No change in oscillatory behaviour. Resonant behaviour between the helium level control and gas storage buffering.

March 15<sup>th</sup>: Adjustment of control parameters in some PID loops – takes system off resonance and saves the control valves, resulting in very few alarms.

- 1) Possibility of losing more gas during a quench or trip due to changed response of valves
- 2) Possibility of changed cool-down characteristics for same reasons
- 3) System can be re-set to original values easily at the control PC (a re-boot of the control PC will re-set all the values). I have made notes of all changes (see also the eLog).
