Trip event on August 25th, 2016 at 18:54:02

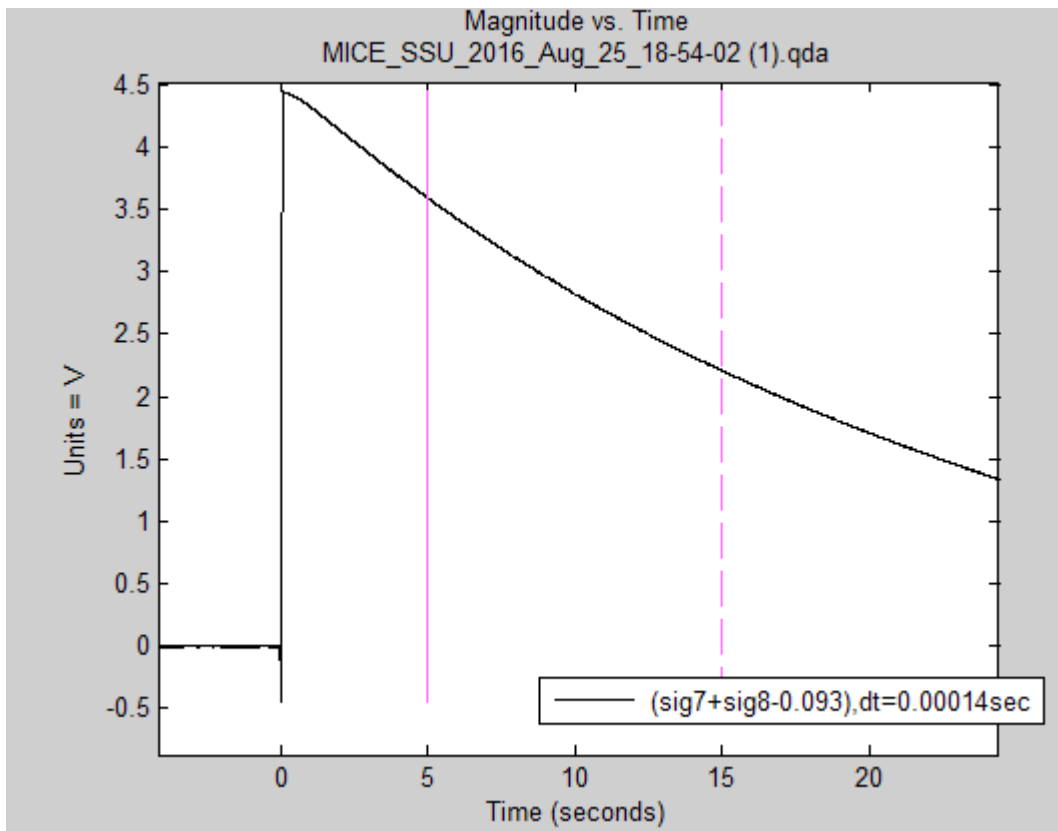
SSU tripped due to unbalance of the E-C-E circuit Half coil signals. The threshold was set to 200 mV. Figure 1 - 3 shows the bucked Half coil signals; different zooms were used. Figure 4 - 6 shows the E1 current signal; different zooms were used.

Figure 1. Shows the Bucked half coil signals. At t=0 the circuit tripped.

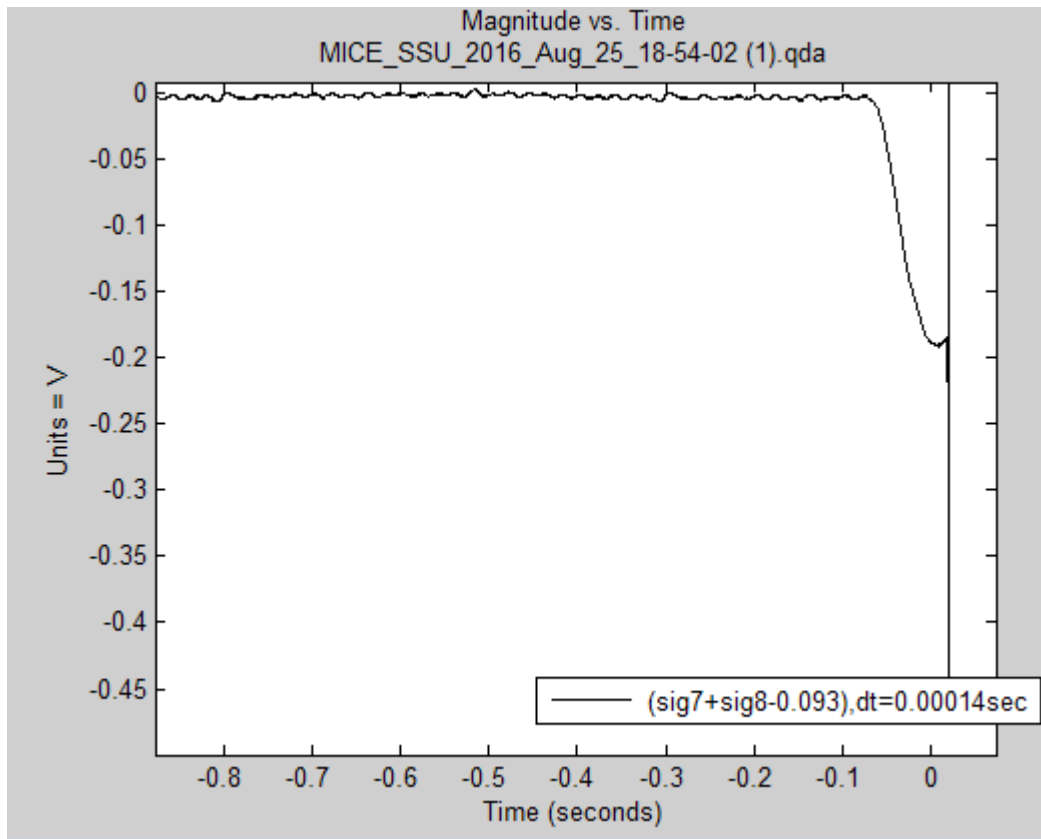
Figure 2. Same signals as Figure 1 zoomed in.

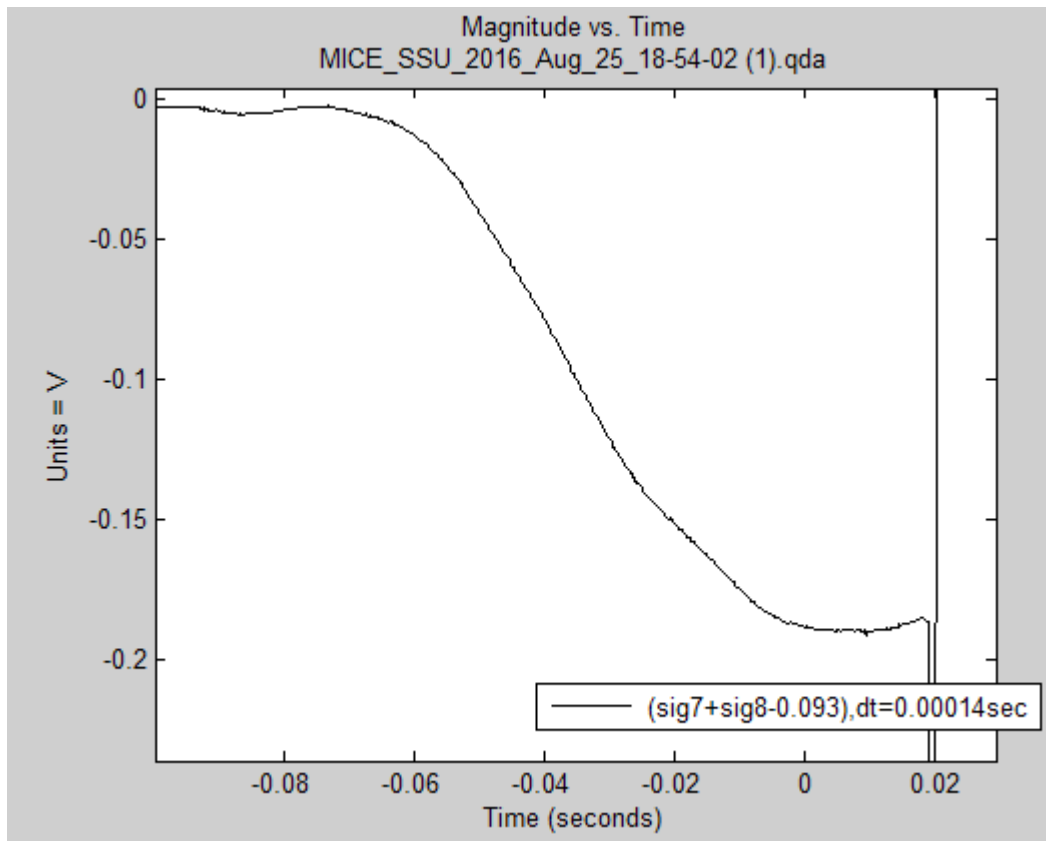
It looks like the E1 circuit current started to change about the same time (~60 msec) when the bucked Half Coil signals show a clear change (see figure 3 and Figure 6). It is quite likely the E1 PS misbehaved and tried to change the current ramp direction. The actual trip however occurred due to a sudden and very fast voltage change. This also could be caused by the PS supply but it is hard to verify it.

Figure 3. Same signals as Figure 1 and 2 just further zoomed in.

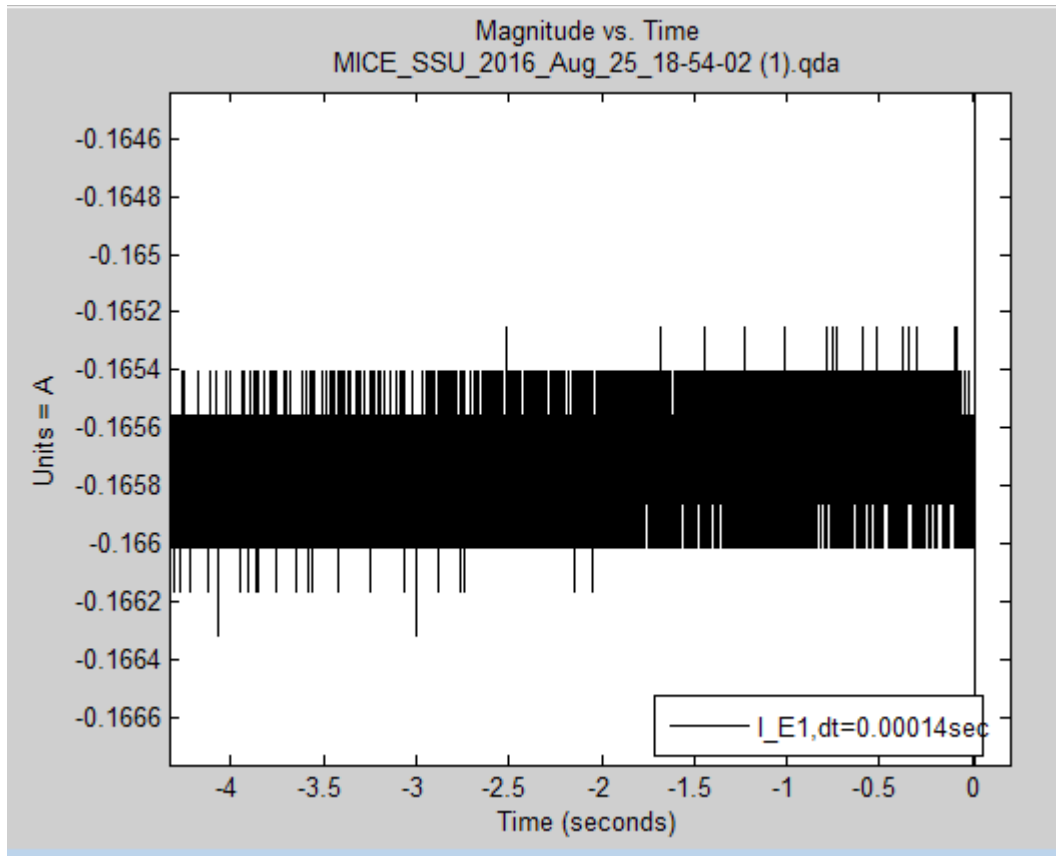
Figure 4. DCCT current signal divided by 100 is shown.

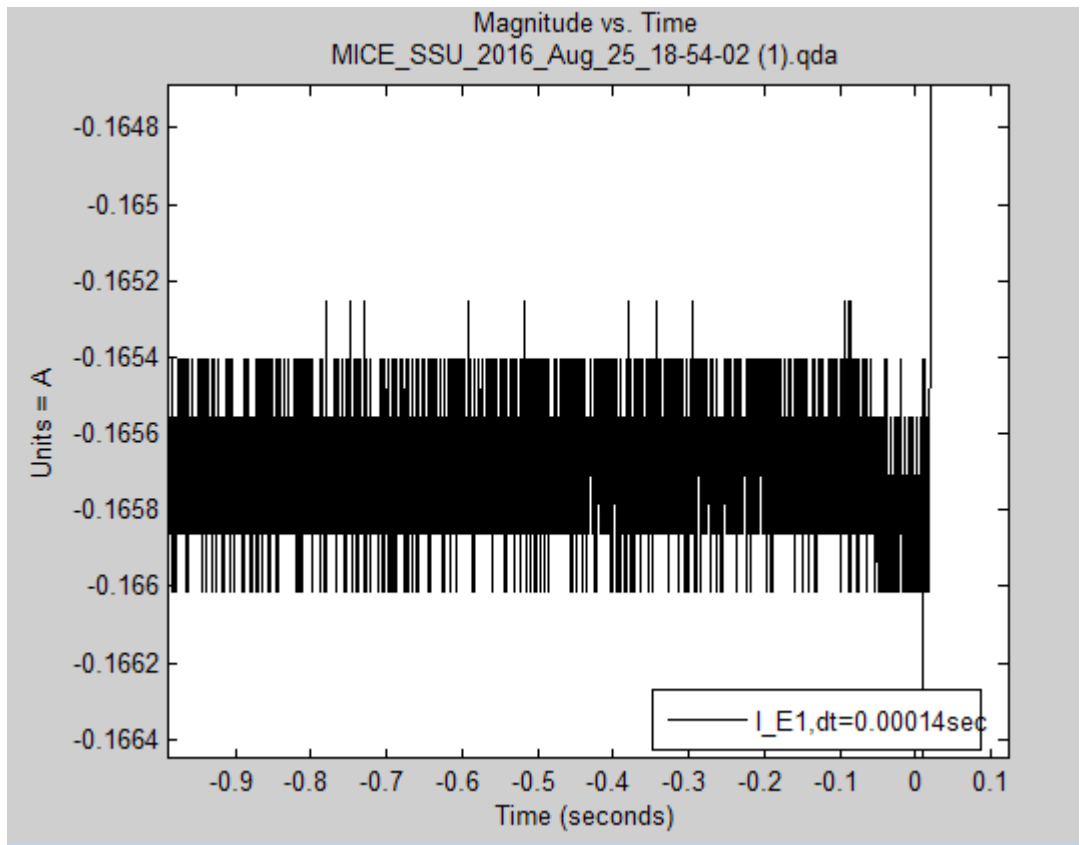
Figure 5. Same signals as Figure 4 zoomed in.

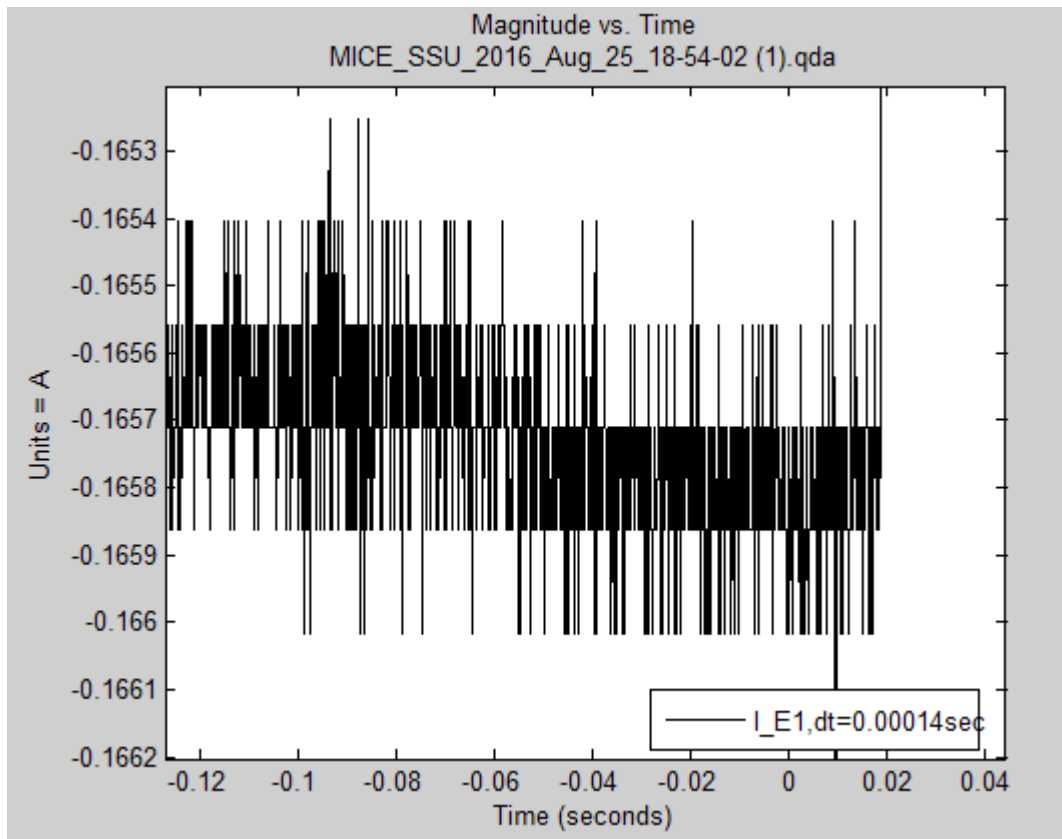
Figure 6. Same signals as Figure 4 and 5 just further zoomed in.
