BRIEF UPDATE ON AXES

(Preliminary) Results

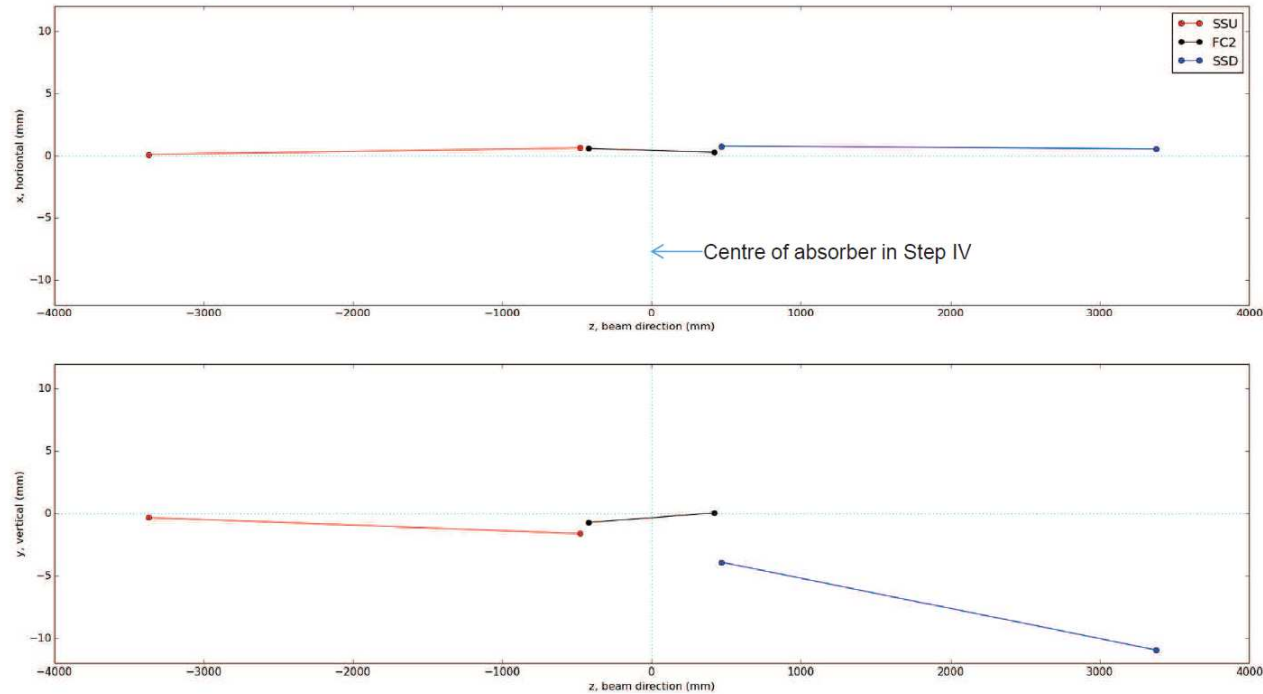
Magnets aligned along mechanical axis. Lines show magnetic axis of SSU, FC2 and SSD.

NB: Error bars are on the order of 0.5 mm

Shown at last week's VC

Did not allow for Flange not being parallel to Warm Bore (= surveyors' x axis)

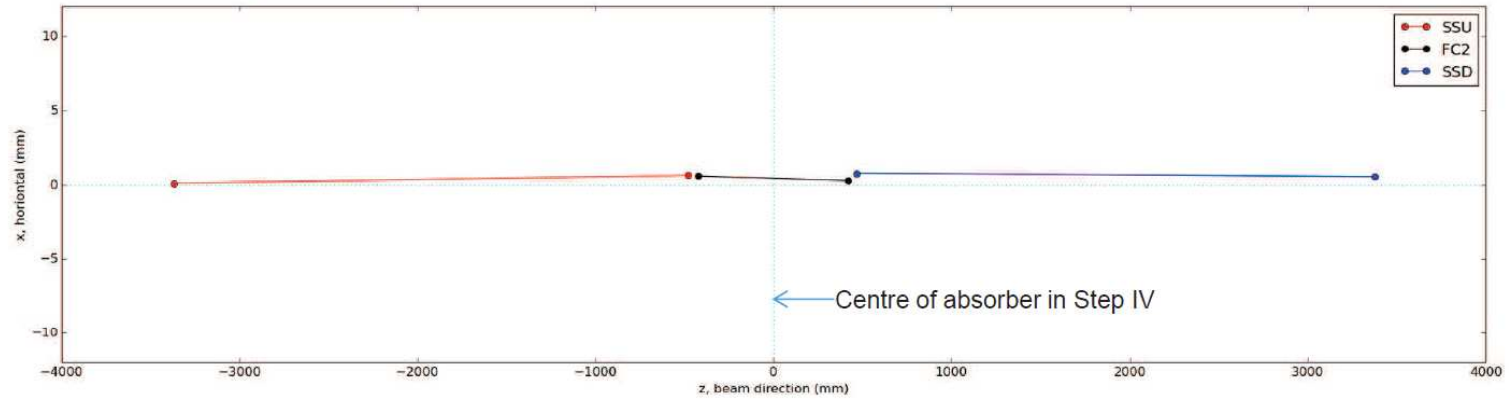
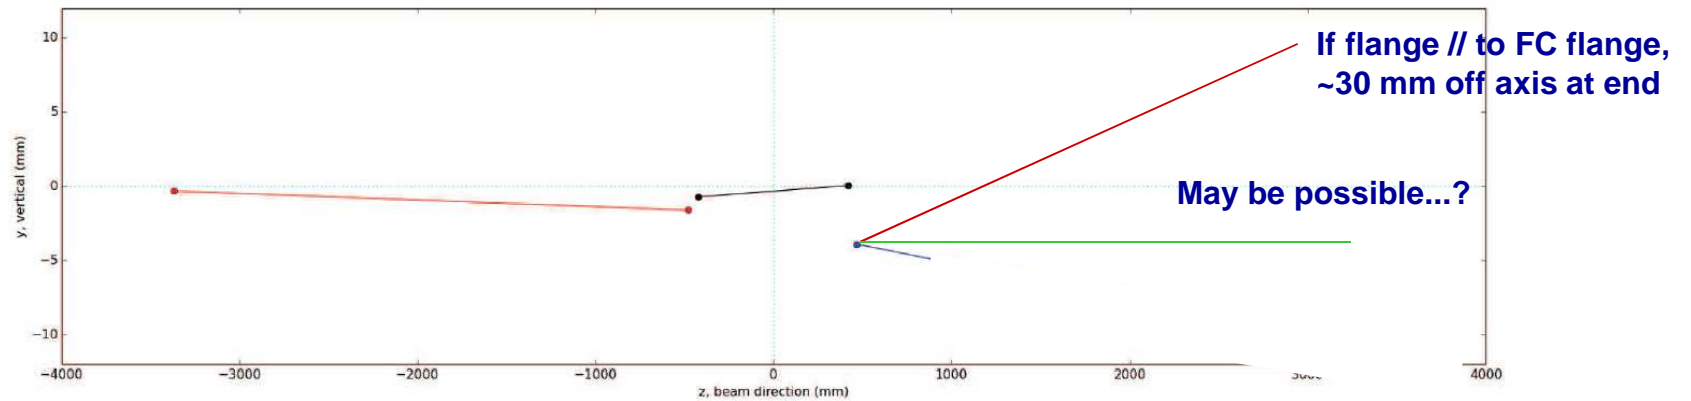
Magnets aligned along mechanical axis. Lines show magnetic axis of SSU, FC2 and SSD.

Not to scale
